[Docket No. 2004-SW-04-AD; Amendment 39-13812; AD 2004-20-07]

Airworthiness Directives; Bell Helicopter Textron Canada Model 222, 222B, 222U, and 230 Helicopters

2004-20-07 Bell Helicopter Textron

Canada: Amendment 39-13812. Docket No.
2004-SW-04-AD.

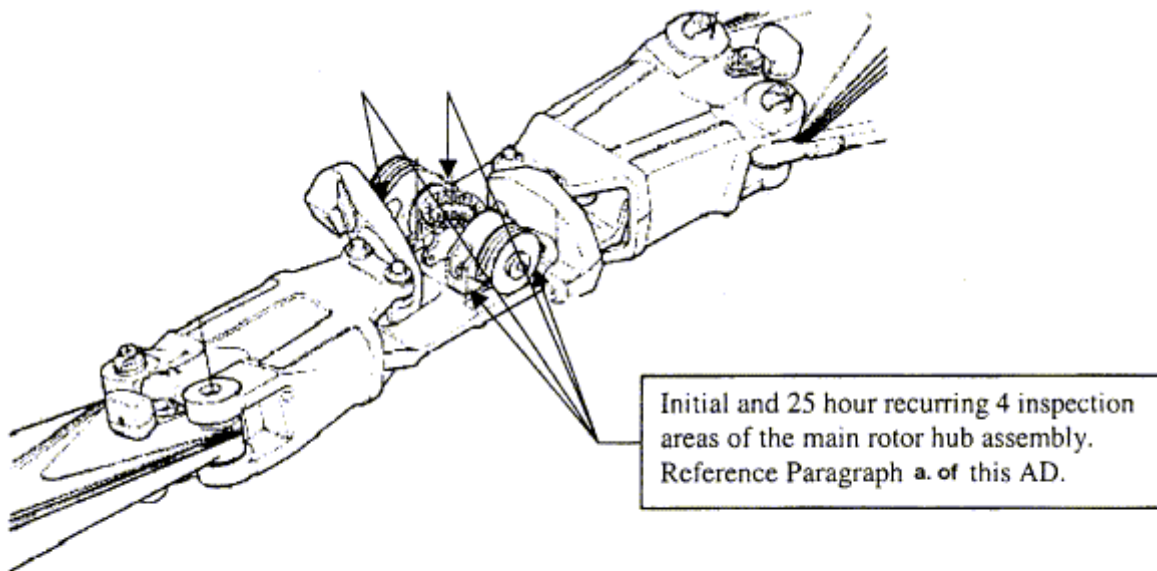
Figure 1. Main Rotor Hub Assembly

assembly, whichever occurs first, and
thereafter at intervals not to exceed 25 hours
TIS, using a 10X or higher magnifying glass,
visually inspect the main rotor yoke (yoke) for
a crack, fretting or buffer deterioration in the
four areas around the flapping bearing
attachment bushings as shown in the following
Figure 1 of this AD:

(1) If a crack is found, before further flight, replace the yoke with an airworthy yoke.

(2) If fretting or buffer deterioration is found on the yoke in the areas shown in Figure

1 of this AD, before further flight, disassemble the hub assembly and further inspect the yoke with a 10X or higher magnifying glass in the four areas shown in Figures 2 and 3 of this AD.

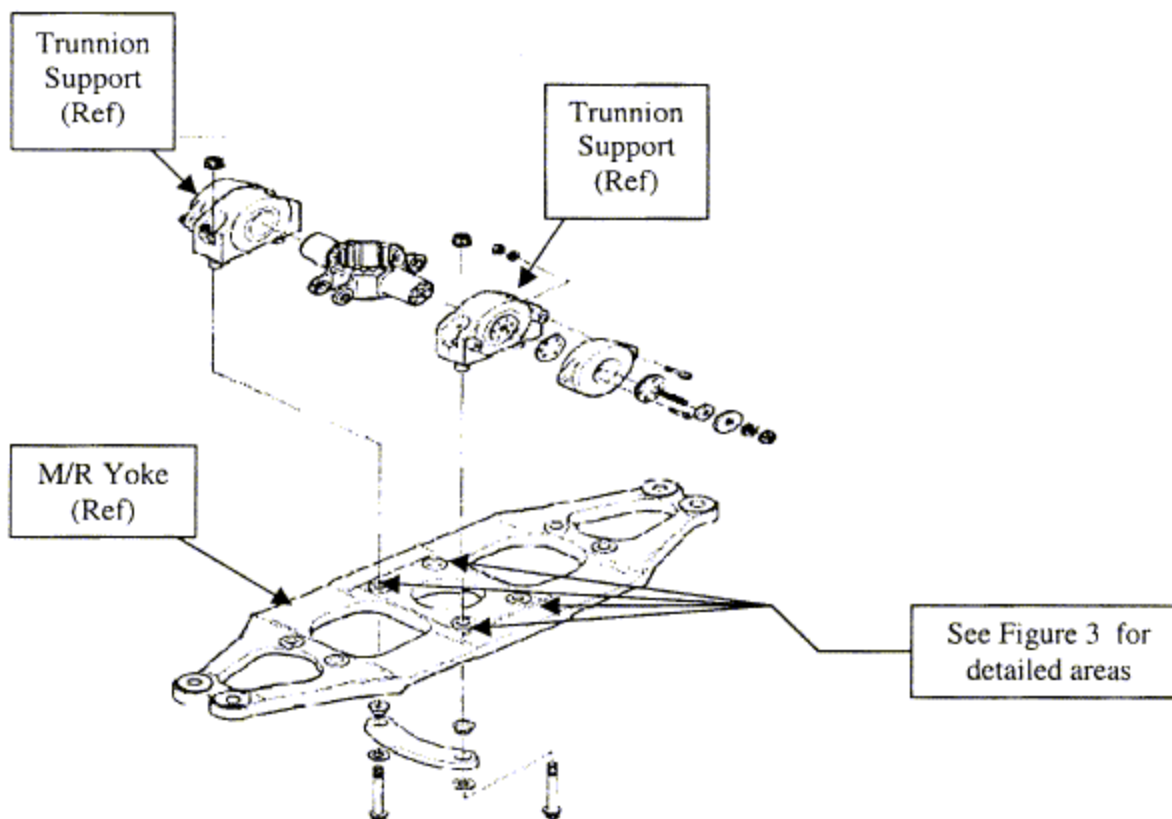
Figure 2. Main Rotor Yoke

Shown with trunnion supports removed.

(i) If a crack is found on any part, before further flight, replace the part with an airworthy part.

(ii) If fretting or buffer deterioration is found on any part, before further flight, repair any unairworthy part or replace the part with an airworthy part.
